Repair of a Model Masonry Arch Bridge using FRP

Y. Tao, J.F. Chen and T.J. Stratford

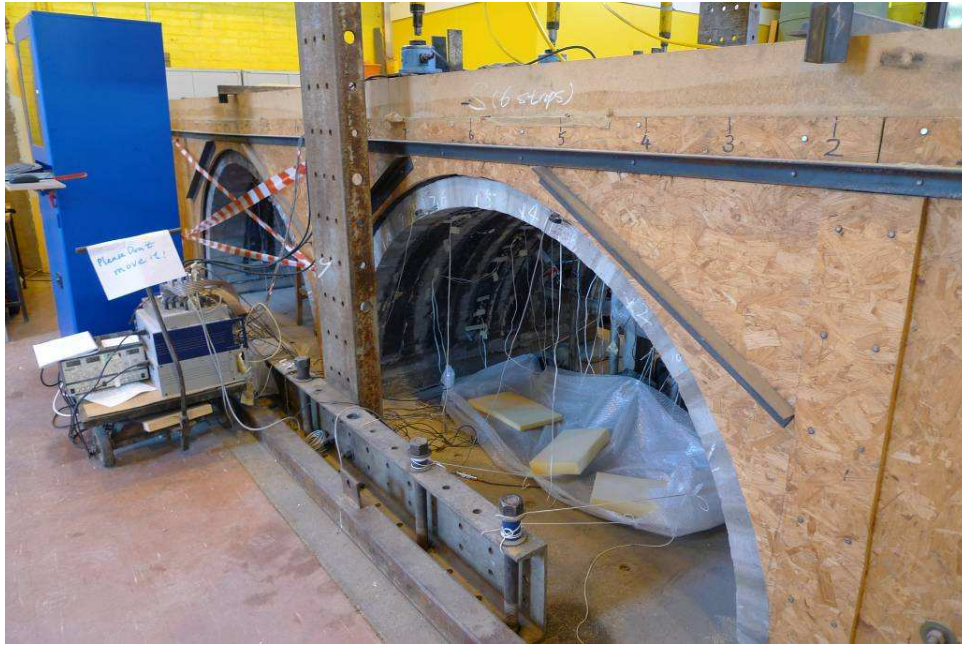
Figure 2. The western elevation of the arches after repair with CFRP

The arches were repaired using pultruded carbon FRP (CFRP) plates, which were bonded to the intrados of the arches as shown in Figures 2 and 3. Three CFRP plates were applied to the northern arch, and six to the southern arch, evenly distributed across the width of the arch (as shown in Figure 3b for the southern arch). The CFRP plates had a cross-section of 100×1.4 mm, a Young's modulus of 170 GPa and tensile strength of 3100 MPa (based upon the manufacturer's values).

The surface of the masonry was prepared by grinding to remove the irregularities and cleaning by wire brush, vacuum and solvent treatment. An epoxy primer was applied before

bonding the CFRP plates to the masonry using a two-part ambient cure epoxy adhesive with about 2mm thickness. Temporary support was provided until the adhesive cured.

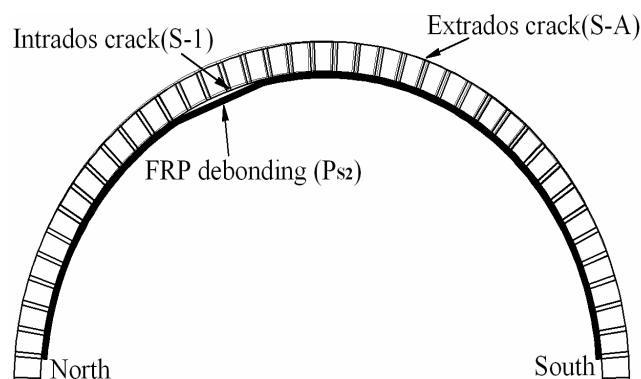
The initial FRP debonding failure occurred at the intrados hinge beneath the loading point at a load 250kN (Figure 4). The opening of the intrados crack (S-1) required high shear stress to be transferred across the adhesive, resulting in debonding of plate Ps₂ from the masonry. At this stage, the bond of the other five CFRP plates remained intact.

Figure 4. Plate P_{S2} on the southern arch after first debonding.

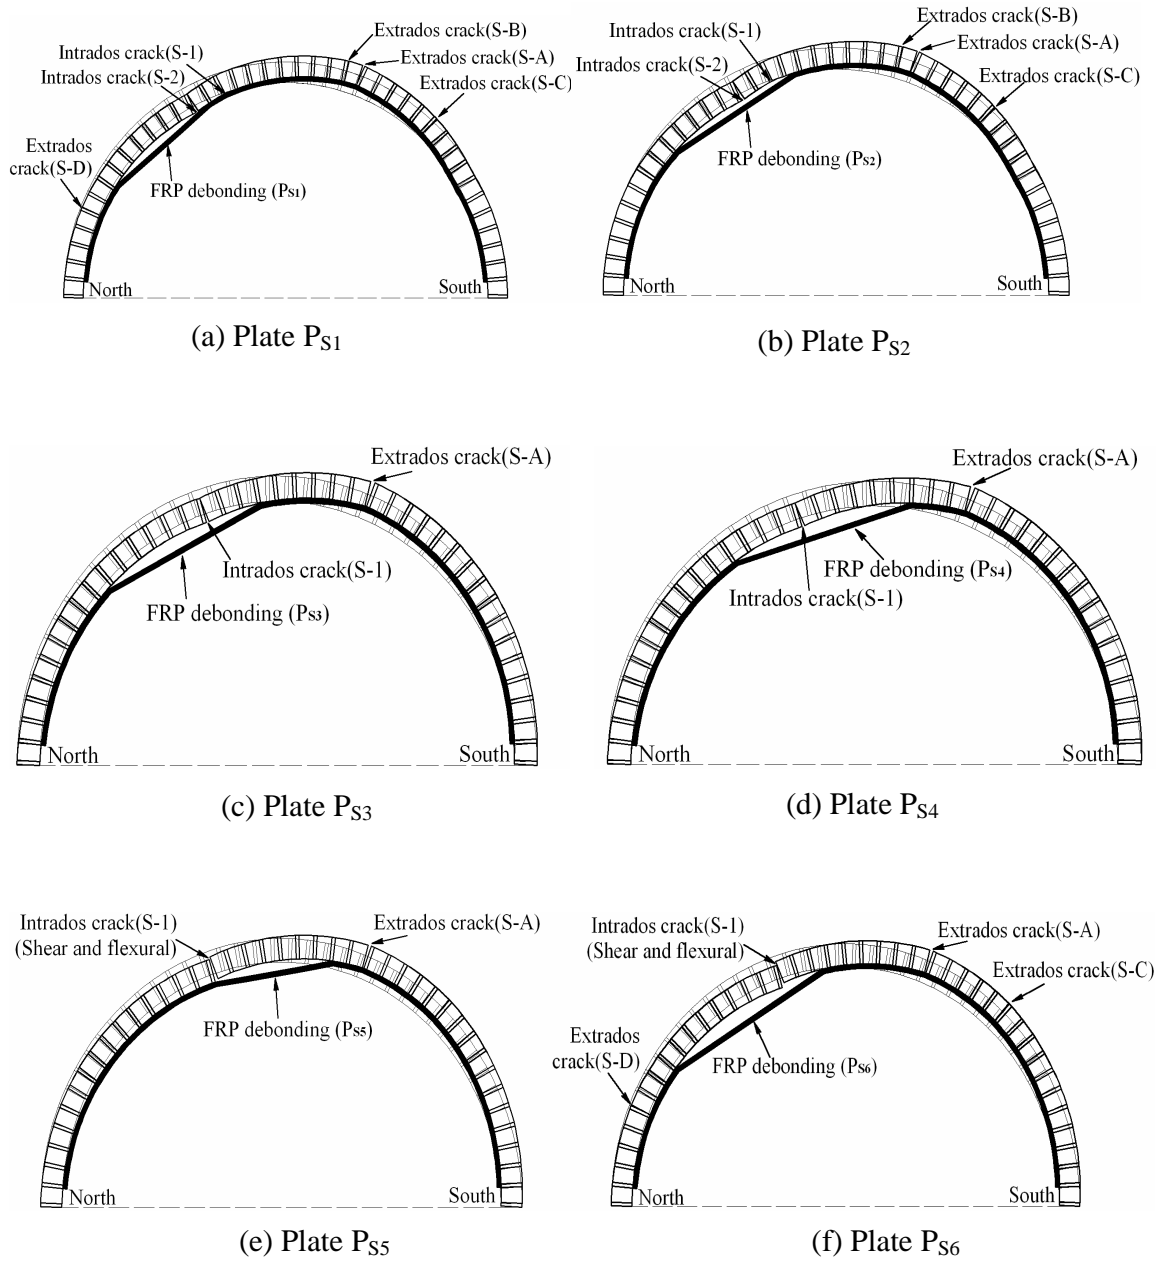
The type of masonry cracking and debonding varied across the width of the bridge as shown in Figure 5 where sections through the arch along each of the CFRP plates are shown. A new intrados crack (S-2) opened two bricks away from the original crack (S-1) at the east side of the bridge as shown in Figure 6. This new crack certainly crossed CFRP plate P_{S1} and P_{S2} , but it was not clear from photographs (direct observation underneath the bridge was not possible due to health and safety concerns) how far it penetrated into the central portion of the arch (P_{S3} and P_{S4}), but it was clear that this new crack did not extend to the west side of the bridge so it did not cross CFRP plate P_{S5} and P_{S6} . At the west side of the bridge, a mixture of rotational opening and shear occurred at intrados crack (S-1) as shown in Figure 7.

Figures 5 and 8 show the extent of debonding of each CFRP plate. Debonding of plates P_{S1} , P_{S2} , P_{S3} and P_{S4} was clearly due to rotational opening of the intrados crack (Figures 5a, b, c and d). The debonding of plate P_{S6} also appears to have been dominated by rotational opening of the intrados crack, as the debonded region bridges the crack (Figure 5f). Plate P_{S5} , however, appears to have been dominated by shearing of the masonry joint, accompanied by peel debonding that started at the intrados crack (Figure 5e).

Figure 5. Deformed shape of the southern arch and position of FRP after final debonding, shown along each CFRP plate section and viewed from the west.

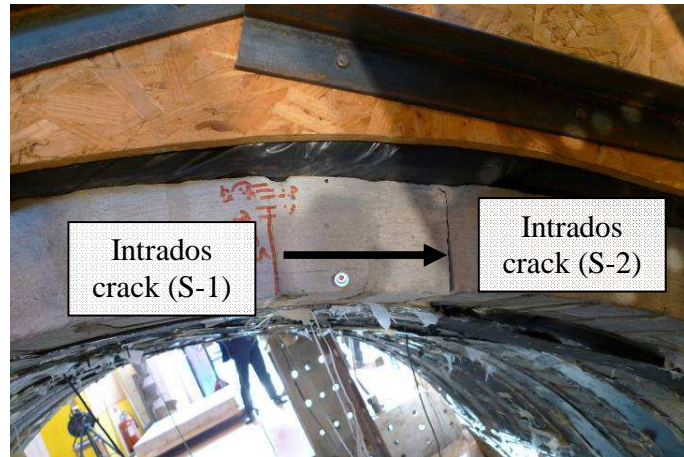
Figure 6. Development of second intrados crack near the loading position - viewed from the west

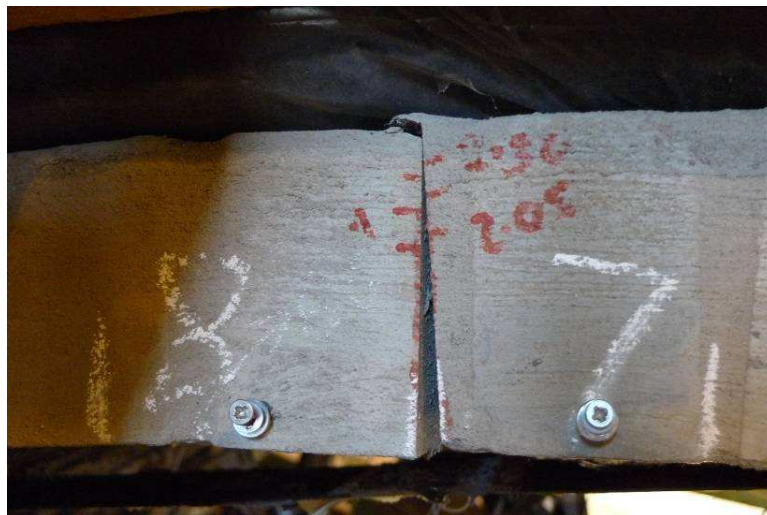
Figure 7. Mixed shear and flexural cracking failure at intrados crack (S-1) - viewed from the east

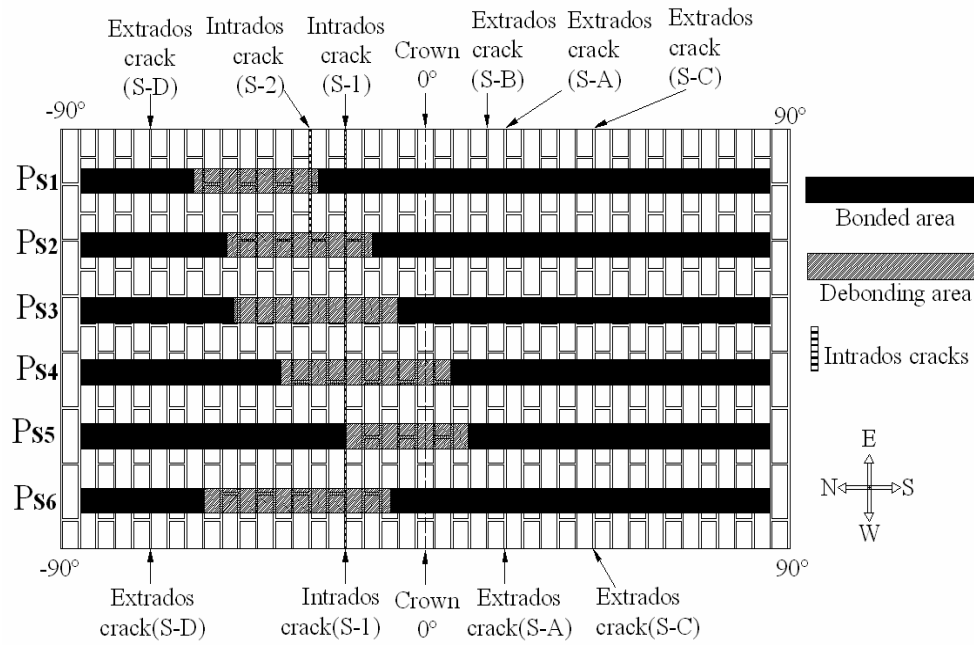
Figure 8. Plan view along the developed length of the southern arch after failure, showing the location of cracks and extent of debonding

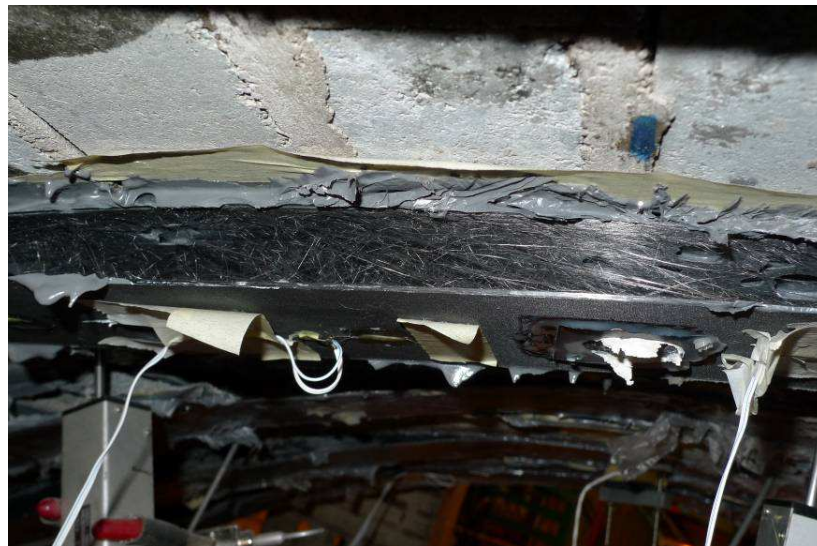
In all cases, separation of the CFRP from the masonry occurred slightly within the masonry, and left a thin layer of brick bonded to the plate to either side of the hinge. Further back from the hinge, however, the separation occurred within the laminate, leaving exposed fibres (Figure 9).

Figure 9. Debonding of the CFRP plate within the laminate, plate Ps₄
